National Register of Historic Places Registration Form

historic name Ellettsville Downtown Historic District

Ellettsville Downtown Historic District, Monroe County, IN

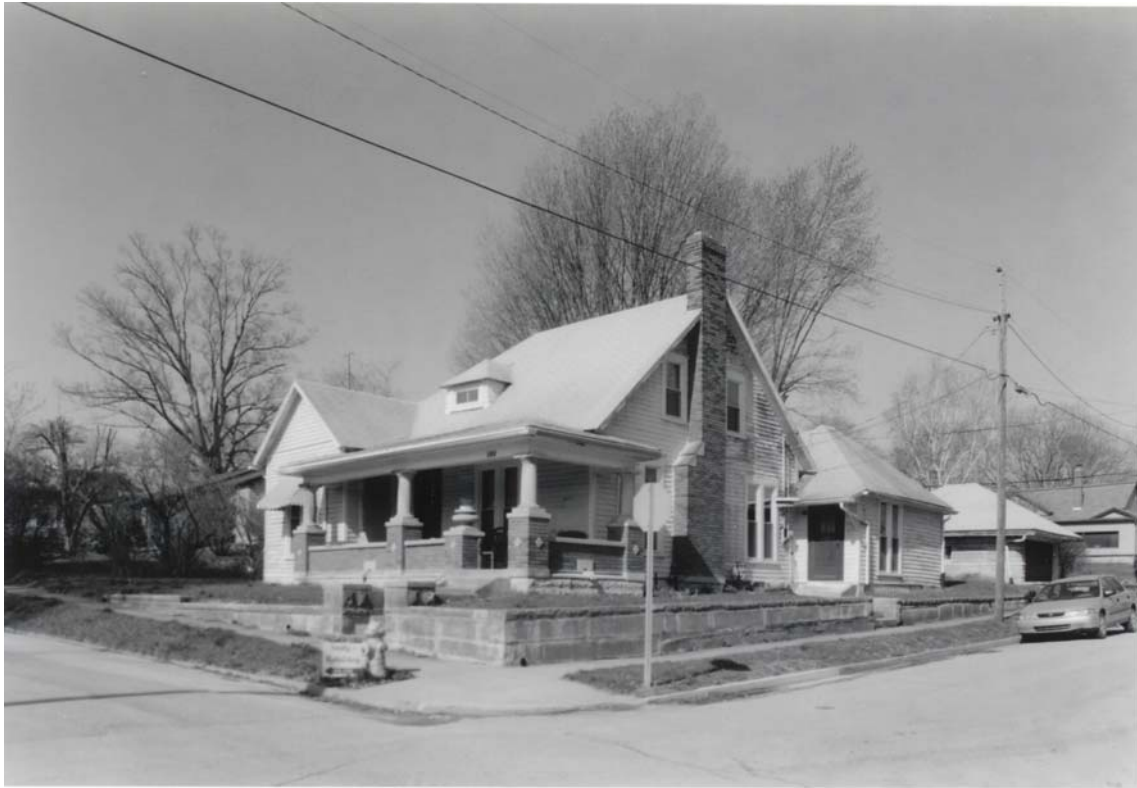
Photo 2

Another pyramid cottage, located at 202 S. Sale St. (contributing, photo #2), is also unusual. This one is distinctive for its Craftsman makeover that was done about 15 years after its circa 1905 construction. The house was expanded, but if viewed from the south it still looks like a pyramid cottage. However, if viewed from the north it resembles a one-and-a-half-story bungalow. A Craftsman-influenced brick and stone porch, much larger than the original porch, fills the traditional pyramid cottage porch space. The south half of the house is built on stone piers, with vertical boards covering the foundation area. The walls are wood clapboard, and there are paired double-hung windows at both the front gable and the south side of the house. Metal awnings have been placed over several windows. The windows have been replaced with windows appropriate to the window openings. The porch has a rock-faced limestone foundation, brick porch railing wall with a smooth cut limestone top. Brick piers support round limestone columns with stone bases and capitals. Inside the porch are the typical two entry doors, and another set of paired

windows. The Association Street side of the house looks like a one-and-a-half-story bungalow, with its brick chimney near the center. The chimney is made of the same tan and brown brick as the porch. On the main floor, there are paired windows on both sides of the chimney and single double-hung windows on the second floor. The roof is asphalt shingle with hipped dormers on the southwest and southeast sides. From the center peak, a ridge extends to the Association Street side of the building, the side with the chimney. The porch roof is hipped. Beyond the main house, a one-story pyramidal roofed addition is attached, from which extends a smaller side-gabled addition.

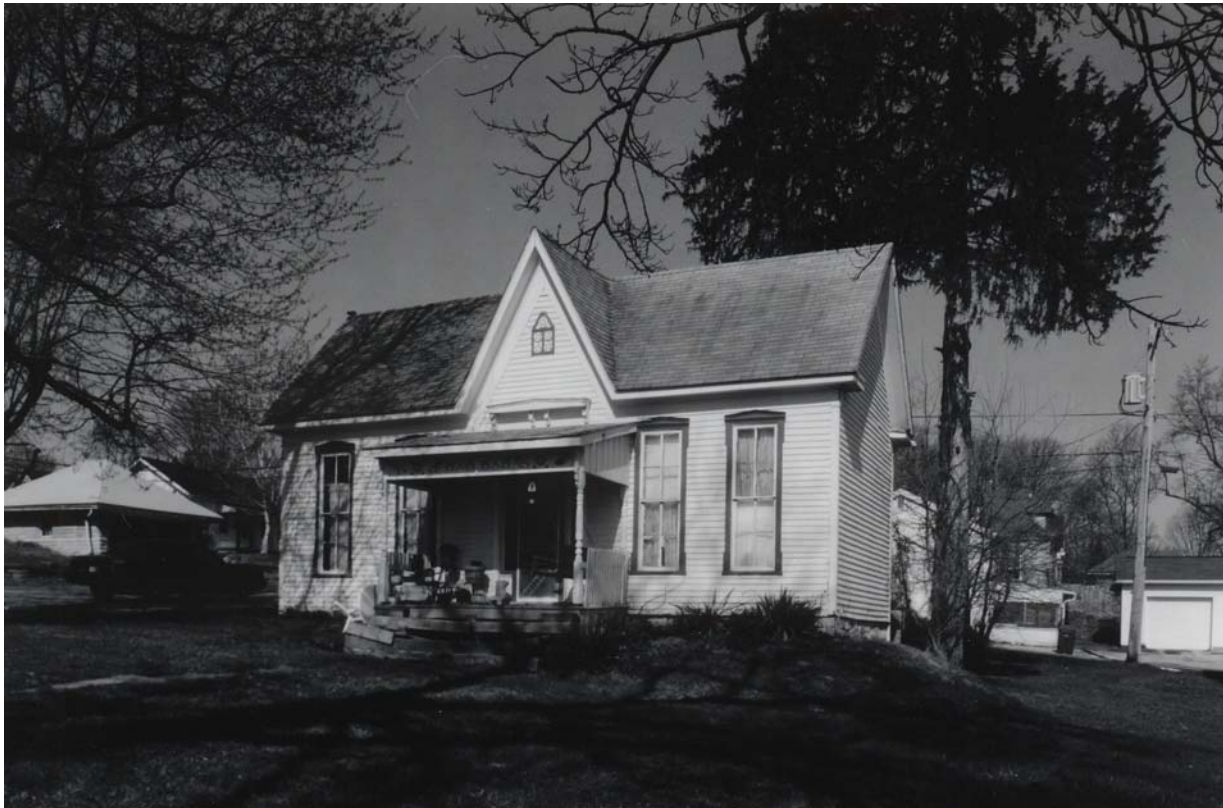
Photo 3

The district's most remarkable central passage house is the c. 1878 Bradford House, at 122 S. Sale St. (contributing, photo #3). While vernacular in form, the house also includes Italianate window hoods, a Gothic Revival center gable with pointed arch vent and a later Queen Anne porch. The house has ornate tracery in its porch frieze board, and delicate cut-out gable vents. The window frames are also refined, featuring pedimented lintels for the four-over-four double hung windows. The front doorway is framed by side lights and transom, and a bracketed pediment above the porch roof. The front porch is Queen Anne style, with turned posts, and is likely a later addition. The foundation is stone and the siding is wood clapboard. A side-gabled addition with rear shed extension fronts the side street, Association Street. The addition is not much older than the house, judging by the wide frieze band where the walls meet the roofline.

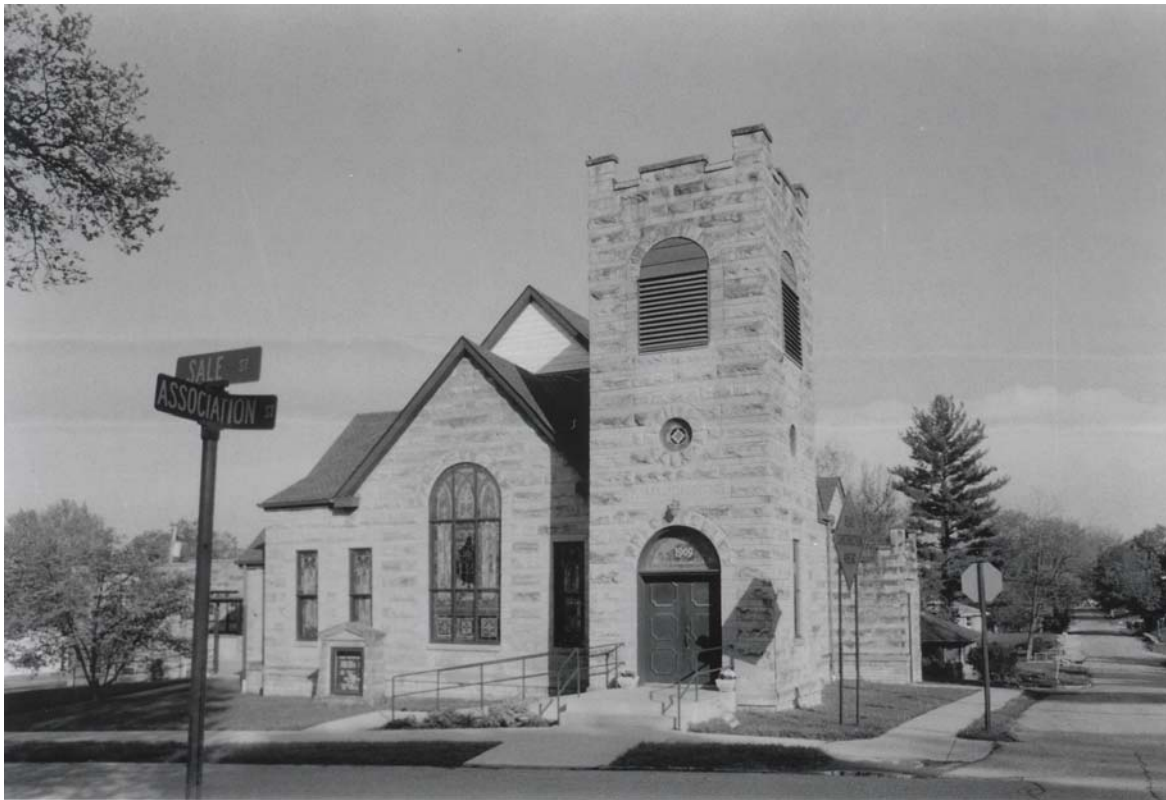
Photo 4

The First Baptist Church, 115 S. Sale St. (contributing, photo #4), built in 1909, is a more modest Romanesque Revival building. This limestone church has rounded arched windows and entrances, with castellated towers. The roof, now covered in asphalt shingles, is a complex combination of gables. There are two gables on the side elevations, and one gable on each of the front and rear elevations, each with returns. A taller secondary gable is set back from the front and rear facades. The church occupies a corner lot and the focus of the design is the massive corner tower which near the intersection of Sale and Association streets. The tower is decorated with stained glass oculus and arched belfry openings. The main entry doors on Sale Street are original double leaf three-panel doors with a stained glass transom showing the 1909 construction date. Recently steps were altered to accommodate a wheelchair ramp. The walls of the building are clad in alternating courses of rock-faced and smooth limestone, except the recessed gables, which originally were wood sided and now have aluminum siding. Below the smooth face limestone water table, the foundation walls are rock face limestone. Each gable has its own arched stained glass windows, with larger windows for the four larger gables, each with its own limestone surround. Most surrounds have smooth face stone along jambs and sills, and rock-faced stone along the curved edges of the arched windows and doorways. On the Sale Street façade, there are two rectangular, double-hung stained glass windows, a set of the larger, arched stained glass windows under the primary gable, then another rectangular window. The Sale Street

elevation then meets the square tower at the building's northeast corner. The tower has arched openings on all four sides for the bell. The bell openings have been enclosed with louvers. On the Association Street side of the tower, there is a double-hung stained glass window. The Association Street façade, beginning at the entry tower, has a double-hung stained glass window, then the large arched stained glass windows, followed by a double-hung stained glass window, then the side entry mini-tower with stained glass transom, then a series of three double-hung stained glass windows. Because the grade drops, there are basement windows under the last three double-hung windows. This pattern continues on the rear, with four double-hung stained glass windows and four basement windows. The church has a two-level addition on the northeast side, covered with rock-faced limestone. The lower level is basement on the northwest side and exposed on the other two sides with a walk-out door at the rear.

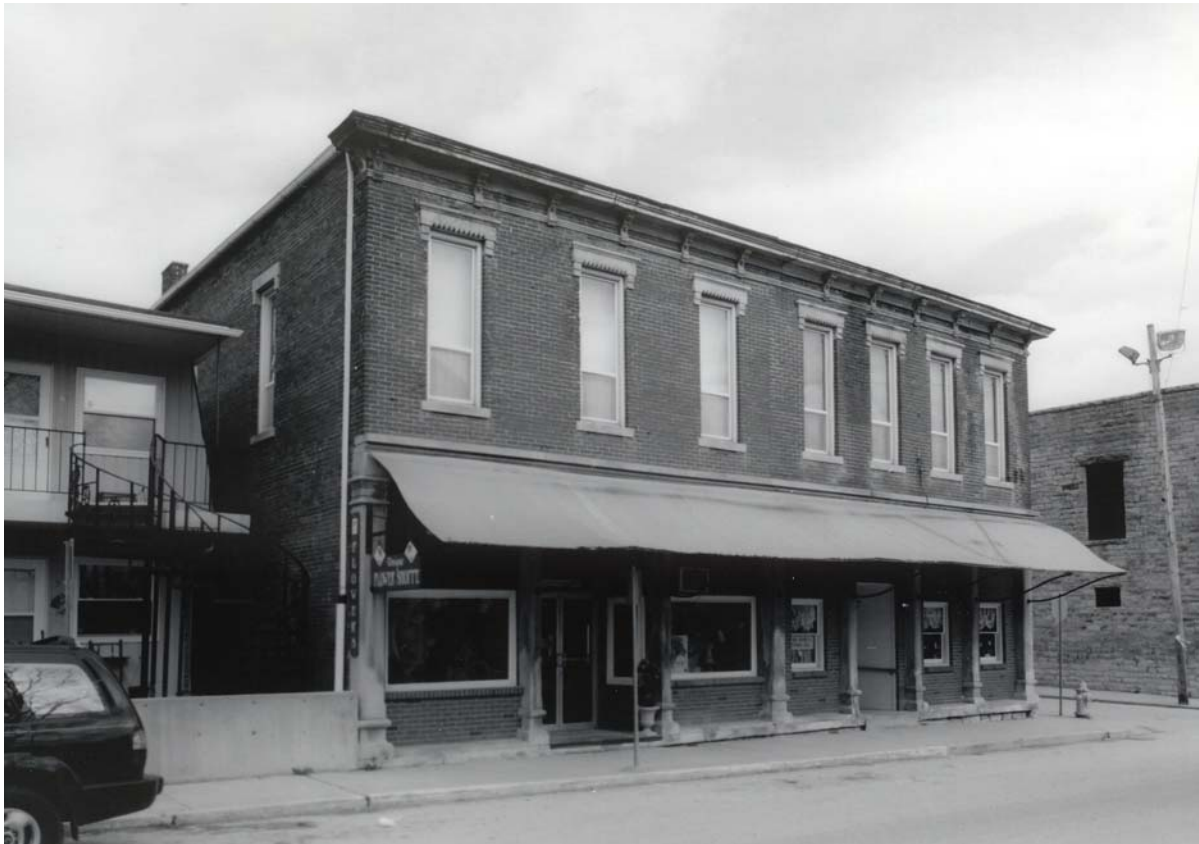
Photo 7

The district's only Italianate building is the two-story brick commercial block I.O.O.F. Building, circa 1885, located at 121-123 N. Sale St. (contributing, photo #7). This Odd Fellows Building has many original features, with a metal cornice and frieze with scrolled bracket entablature, elaborately-carved limestone second-story window hoods with lintels decorated in a delicate sawtooth pattern. Eight limestone pilasters at the storefront level carry a stone entablature across the storefront level, which is partially covered by a curved metal awning. The building is currently occupied by the Unique Flower Shop. The most altered feature is the storefront, where large window areas were replaced with smaller windows and wood and brick infill. However, the pattern of solids to voids in the fenestration has been maintained. Other changes include the second story windows, which were replaced with newer ones that fit the openings, and altered entries that replaced the historic doors and transom windows, though the left door preserves the double-door appearance and recessed design.

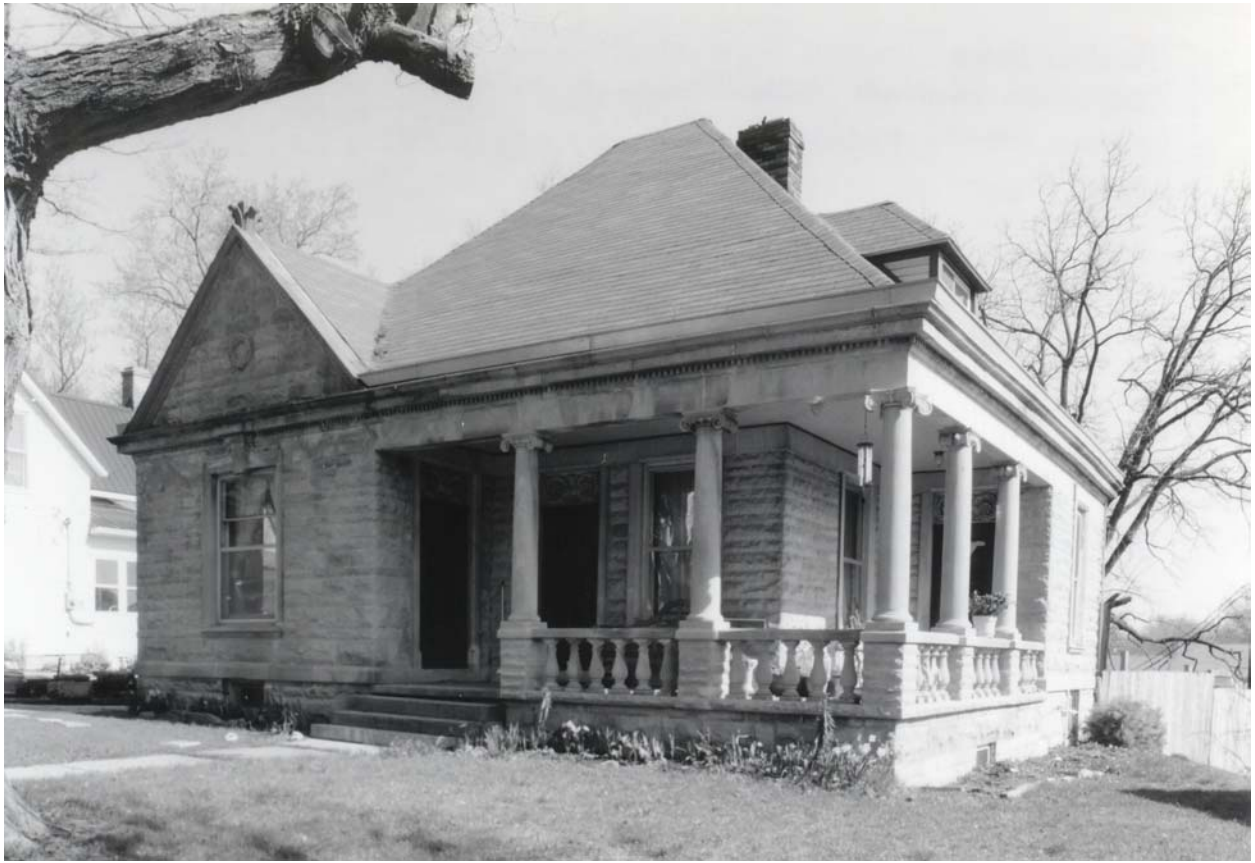
Photo 21

The Wickens House, at 620 W. Association St. (contributing, photo #21), is an extraordinary pyramid cottage because its exterior is limestone embellished with carved and turned stone. The porch is especially ornate, with vase-shaped balusters and stone columns with Ionic capitals. The builder, Edward Wickens, was a Matthews Stone Company employee who with the help of friends constructed the house in 1909 for his home. On the main façade, the foundation is rock-faced limestone, with a smooth dressed limestone water table, then a wall of rock-faced limestone of varying dimensions, then a smooth dressed frieze and cornice, with dentils. Above the cornice, the rows of rock-faced stone continue. The gable has its own cornice with carved frieze, as well as a decorative wreath of stone. The gable peak is topped with carved stone finial. There are two windows on the front façade, both have stone trim, with the one under the gable having a decorative bracket. Both of the front doors have stone surrounds with carved limestone transoms. The roof is asphalt shingle, with dormers added on the sides and a brick chimney to the rear of the roof peak.

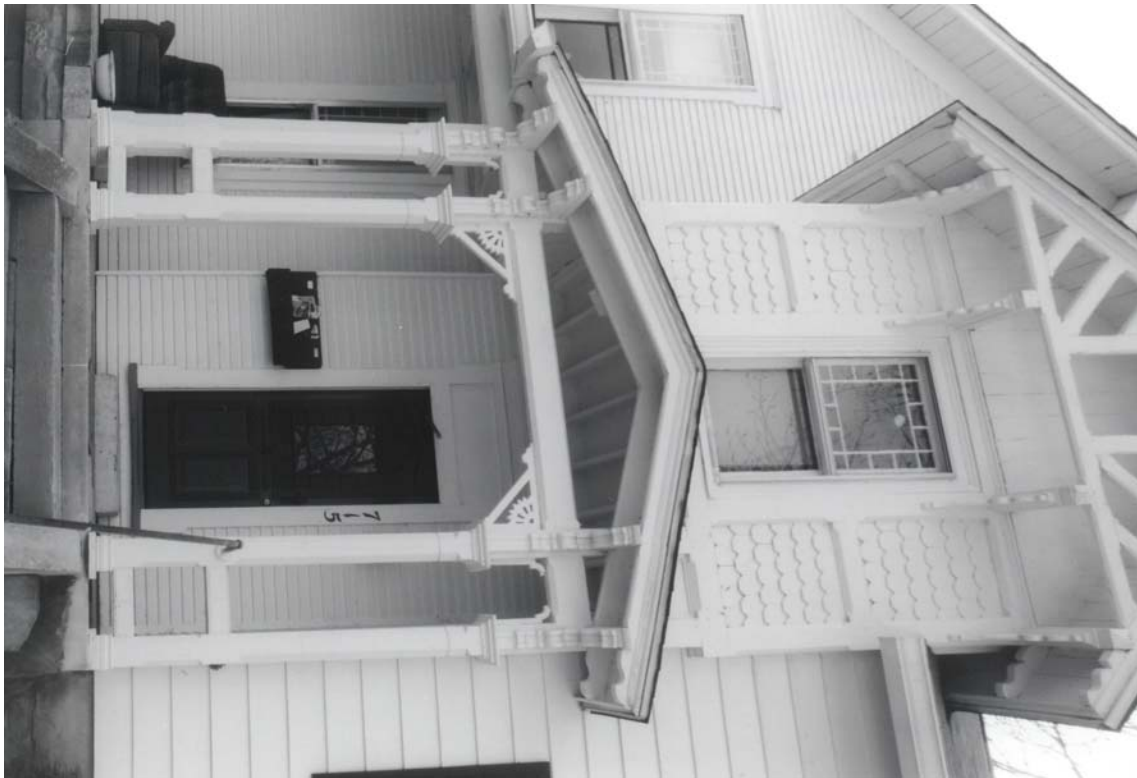
Photo 23

Larger than the gabled-ells is the Captain Gilbert Perry House (715 W. Association St., c. 1890, contributing, photo #23, 24). The cross-gabled, Stick Style house has been altered in some areas and expanded, but it retains a great deal of its ornament, especially on the front facade. The front façade features a gabled entrance with open tie beam at the porch, with paired chamfered wood columns and brackets. The porch wraps around the north and east sides of the house, but was subsequently enclosed at the corner. Above the entrance is a projecting bay, with half-timbering and fish scale wood-shingle siding, carved rafter tails and a decorative truss with elaborate brackets. The side of the bay has two round windows. All four of the front gables have carved rafter tails and brackets. Four of the original double-hung windows of this circa 1890 house have Queen Anne upper sashes with large panes of glass surrounded by 20 small panes. The double-hung window in the projecting bay has the same pattern, but with 16 small panes. The same pattern is found in the front door, with 24 small panes. The attic window and attic dormer windows on the front façade are two-over-two double-hung windows. The house has a limestone foundation, wood clapboard and wood shingle siding, as well as a large replacement window on the first floor and some walls covered in aluminum siding. The roof is covered in asphalt shingles. A two-story addition is on the rear.
